**NASA  
Reference  
Publication  
1291**

# Fractography Handbook of Spaceflight Metals

Rebecca J. Derro

Rebecca J. Derro  
*Goddard Space Flight Center*  
*Greenbelt, Maryland*

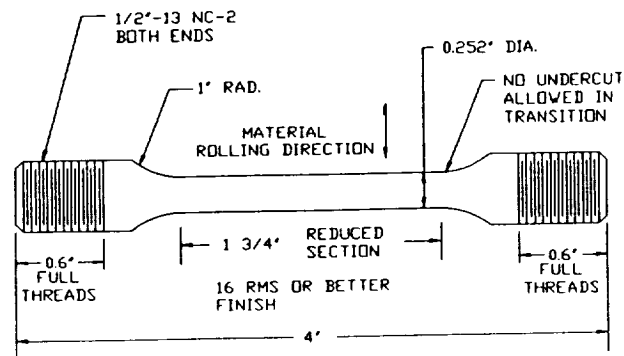
Figure 1. ASTM A370 Smooth Tensile Specimen

The specimens are prepared according to American Society for Testing and Materials (ASTM). Two types of test specimens were prepared; one with a smooth machined gauge area made in accordance to ASTM A370 (Figure 1), and the other with a circumferential notch in the machined gauge area made in accordance to ASTM E602-81 (Figure 2). The specimens are designed to have a reduced cross-section at mid-length for a uniform distribution of stress and to localize the zone of fracture. The smooth sample simulates a bulk alloy and the notched sample simulates a very sharp stress concentrator such as a fillet.

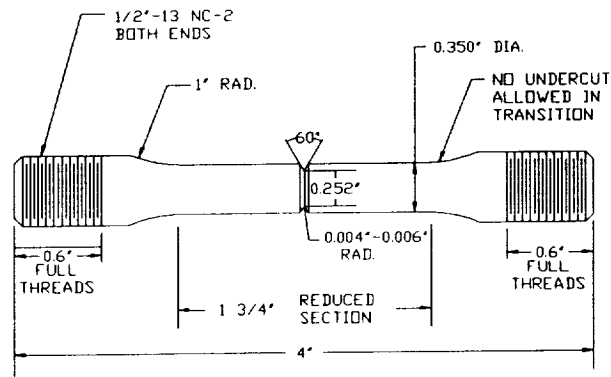
Figure 2, ASTM E602-1 Notched Tensile Specimen

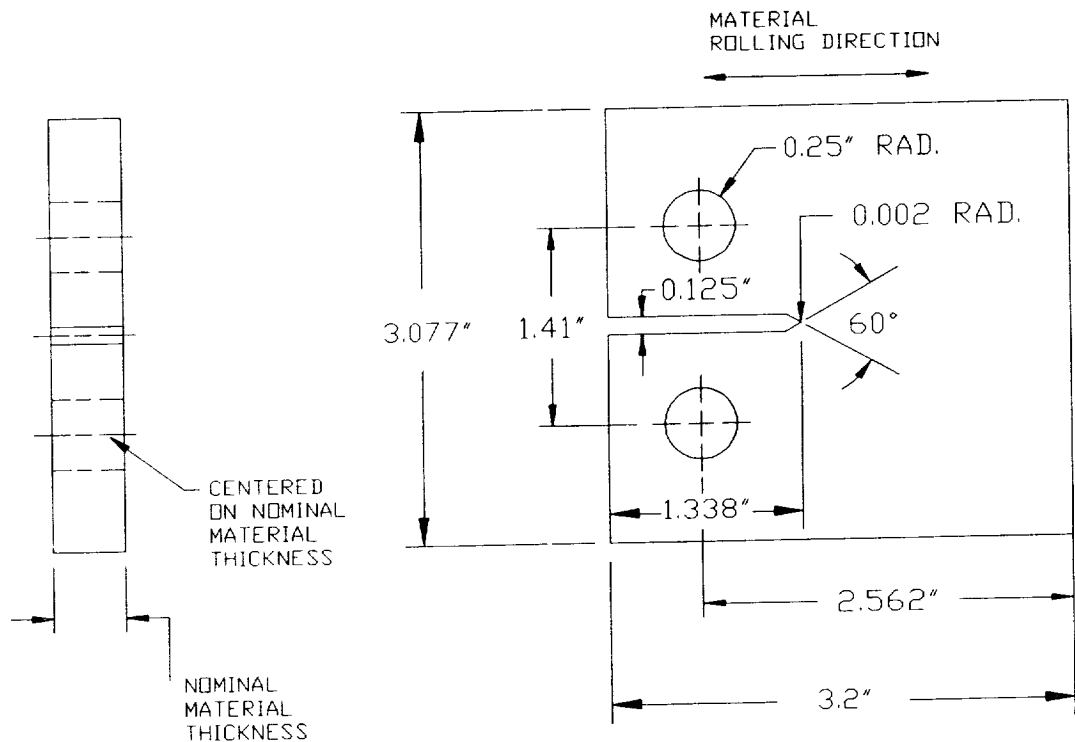
Figure 3. Compact tension specimen

For tension-tension fatigue loading, a compact fracture toughness specimen is loaded cyclically until a preexisting crack grows. This test simulates a fatigue failure of an alloy in service. Fatigue crack growth in metals occurs due to repeated loading and unloading at the crack tip. Tension-tension fatigue specimens were manufactured according to ASTM 399 Appendix A4 (Figure 3).

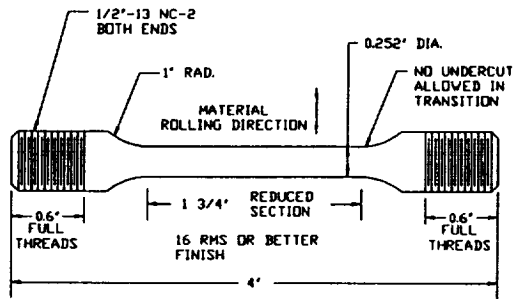
Figure 1-b. Smooth tensile overload specimen, 4" long, 0.252" diameter

Smooth tensile specimens have dimensions as pictured in Figure 1-b. The notched tensile overload specimens have dimensions as pictured in Figure 1-c. The compact tension specimens were made according to the dimensions in Figure 1-d.

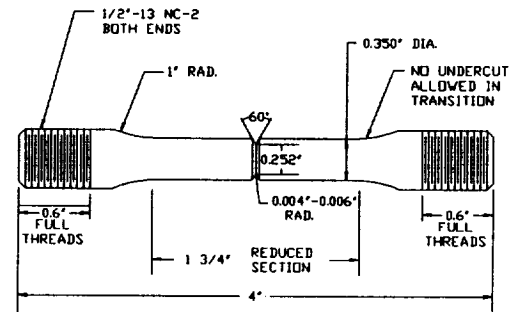
Figure 1-c. Notched tensile overload specimen, 4" long, 0.004-0.006" root radius, 0.252" notch diameter.

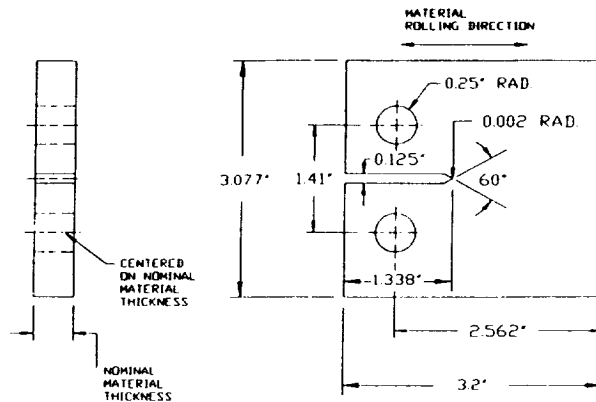
Figure 1-d. Compact tension specimen

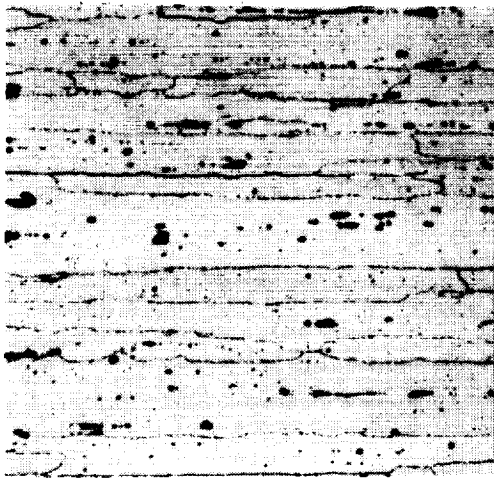
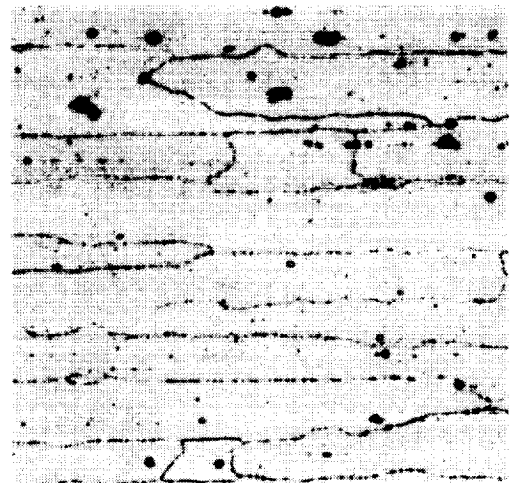
Fig. 1-1 200X.

Fig. 1-2 400X.

Keller's etchant used for all micrographs. Figures 1-1 and 1-2 show the elongated grains and precipitates typical of the microstructure of this alloy.

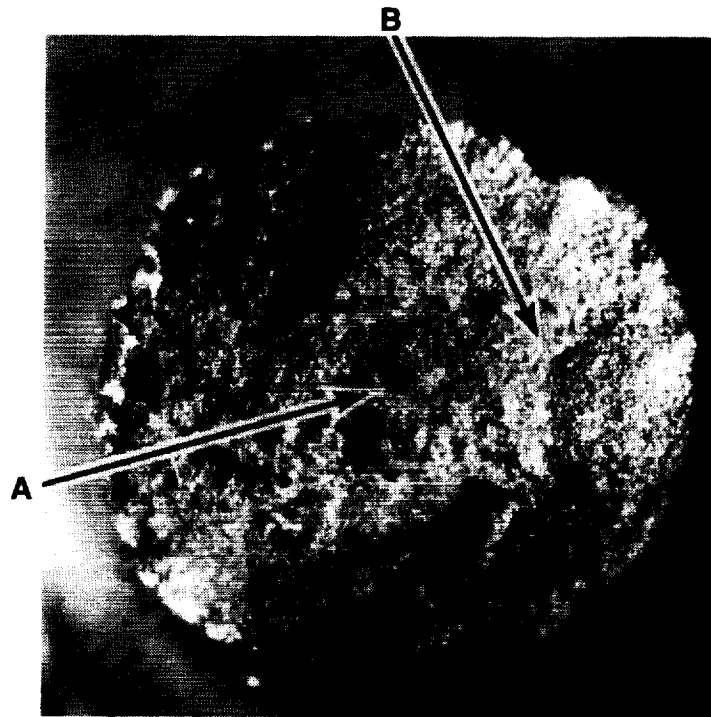
Fig. 1-3 15X  
Optical photomicrograph of fracture surface.

The macrograph of this specimen is displayed in Figure 1-3. This specimen exhibits a cup-cone morphology with a rough surface and a pronounced shear lip. Two areas were documented; Area A which is near the center of the specimen; Area B which is located at the edge of the specimen where final fracture occurred by ductile shear.

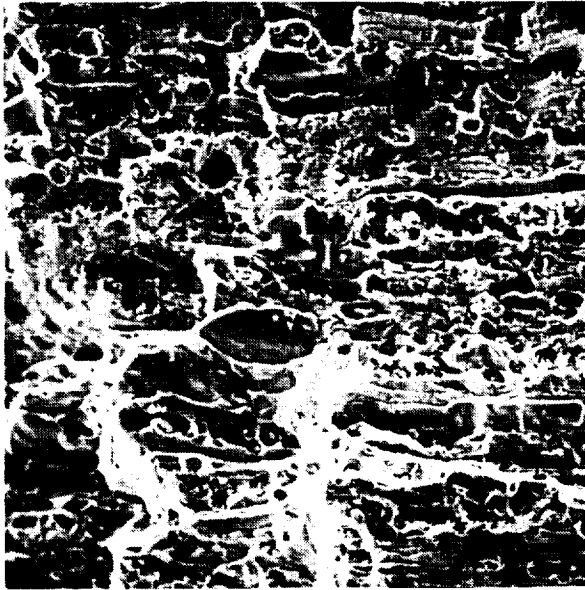
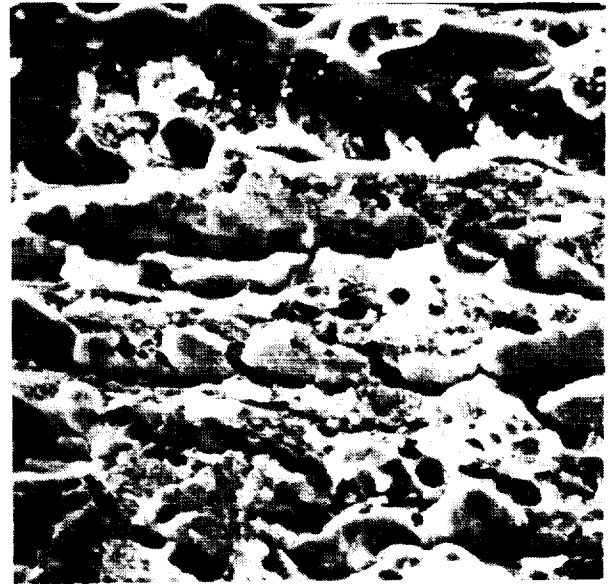
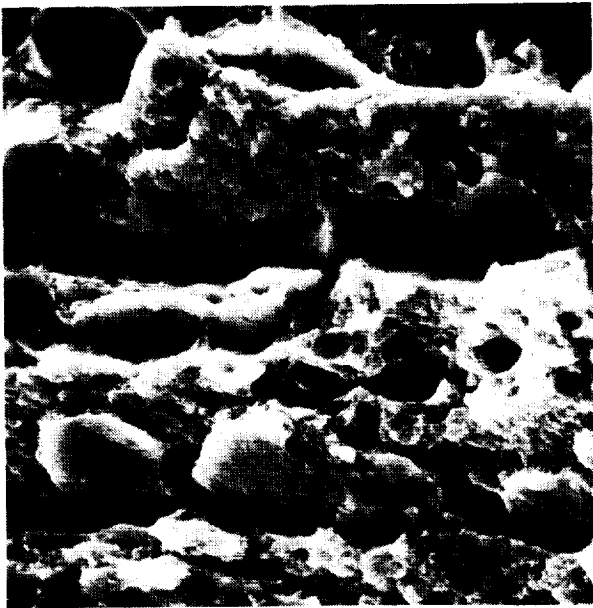
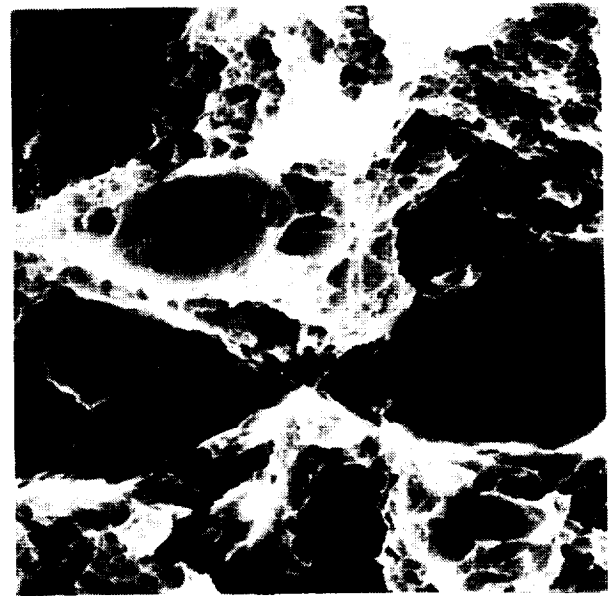
Fig. 1-4 160X  
Region A. Area near the center of the fracture surface.

Fig. 1-5 640X  
Region A. Enlargement of the center area in Fig. 1-4.

Fig. 1-6 1250X  
Region A. An area at the center of Fig. 1-5.

Fig. 1-7 5000X  
Region A. An area at the center of Fig. 1-6.

Figures 1-4 to 1-7 Area A: These micrographs show typical features of area A. The varied and elongated topography reflects the elongated grain structure of this alloy.

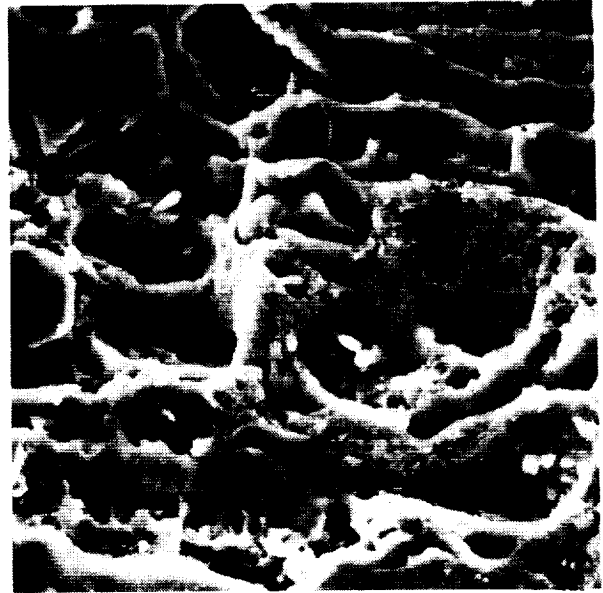
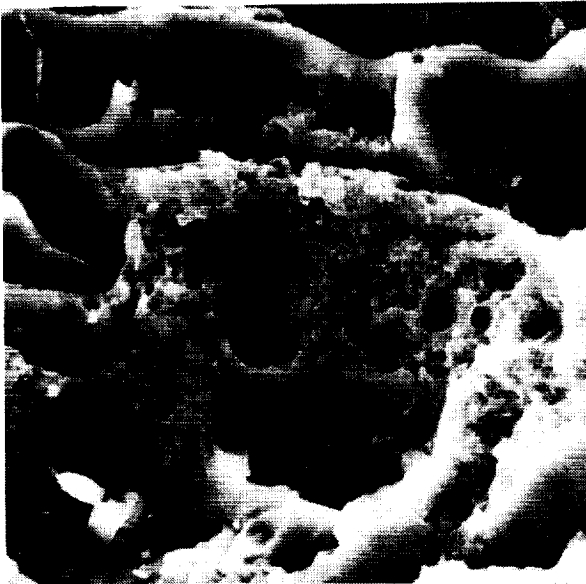
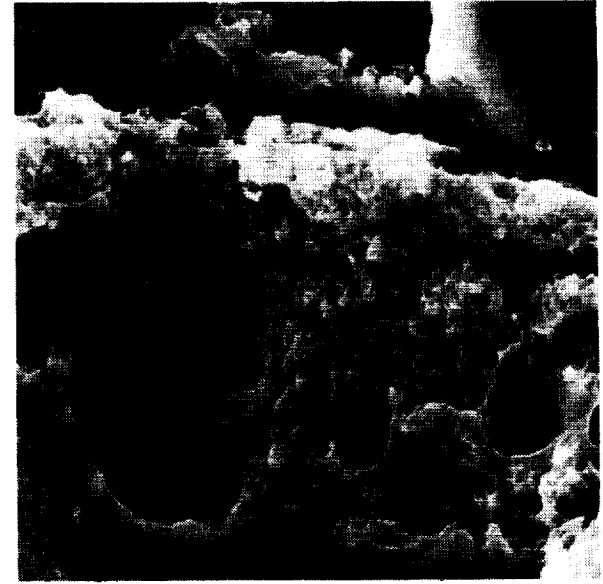
Fig. 1-8 160X.  
Region B. An area on the shear lip.

Fig. 1-9 640X  
Region B. An area at the center of Fig. 1-8.

Fig. 1-10 1250X.  
Region B. An area at the center of Fig. 1-9.

Fig. 1-11 2500X.  
Region B. An area at the center of Fig. 1-10.

Figures 1-8 to 1-11 show typical features of area B. The shear lip has an oriented structure (Figures 1-8, 1-9) containing microvoids (1-10, 1-11). The features are similar to those in area A.

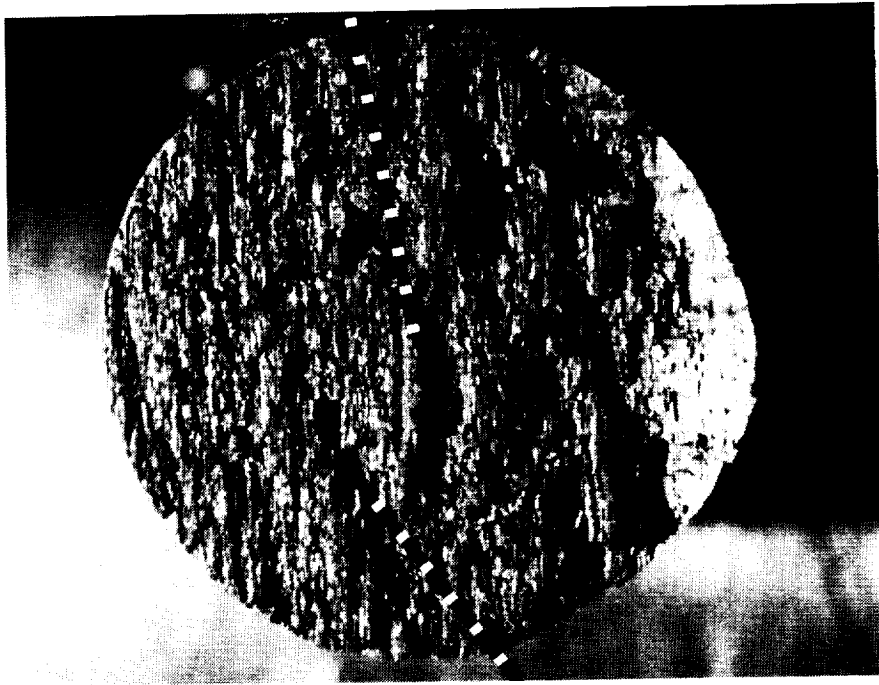
Fig. 1-12  
Photomicrograph of fracture surface.

The macrofractograph of this sample is shown in Figure 1-12. The surface of this fractured sample is rough and uneven and reflects the grain orientation that was produced by working the plate from the ingot. Area A represents the center of the sample and area B is near the edge of the sample.

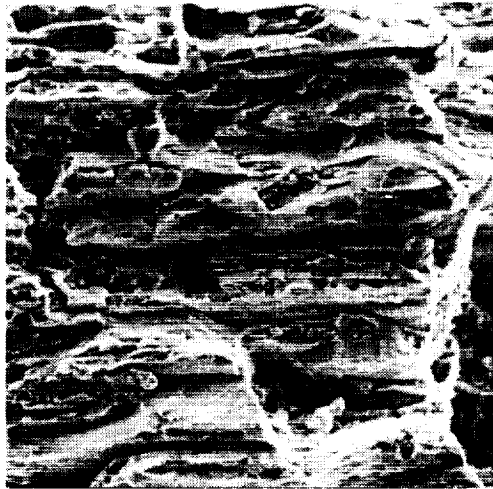
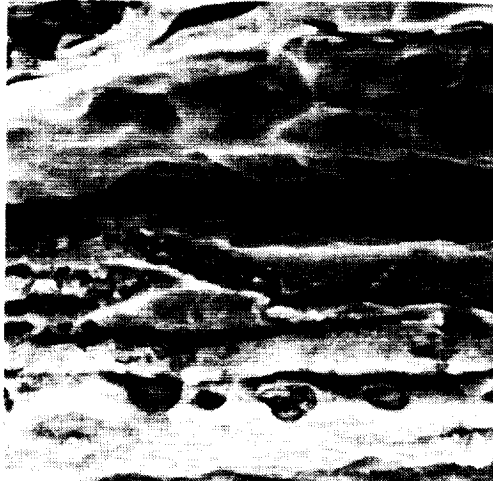
Fig. 1-13 160X  
Area A. An area at the center of the fracture.

Fig. 1-14 640X  
Area A. An enlarged view of the center area in Fig. 1-13.

Fig. 1-15 2500X.  
Area A. The brittle inclusions in Fig. 1-14.

Figures 1-13 to 1-15 Area A: Note the more brittle nature of the fracture than the room temperature case. We see very little evidence of ductile dimples except at high magnification as in Figure 1-15. There are many inclusions and step-like features.

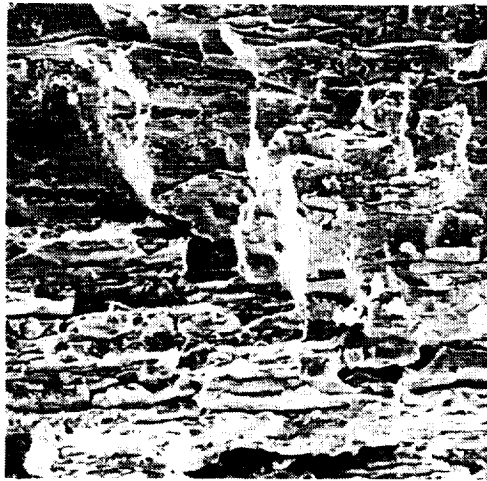
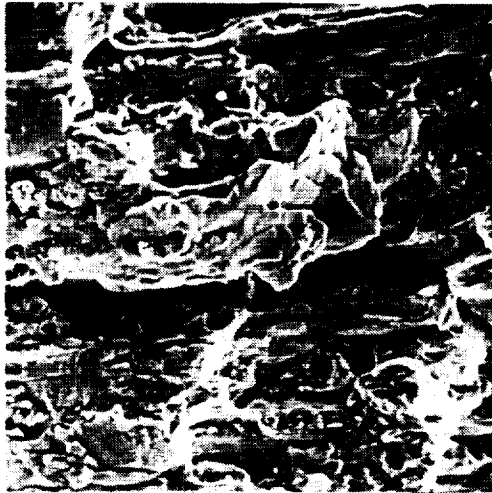
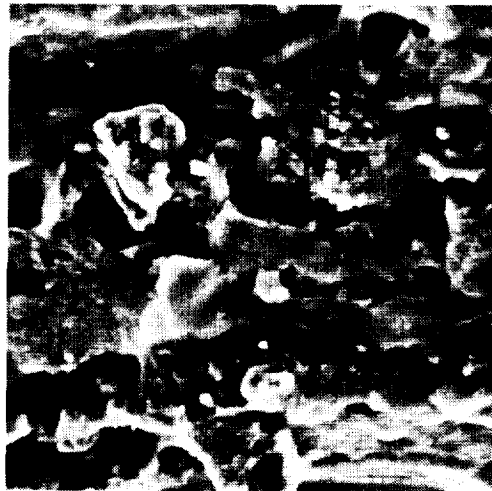
Fig. 1-16 80X  
Area B. A low magnification picture  
of the shear lip.

Fig. 1-17 160X  
Area B. A closer view of the center  
of Fig. 1-16.

Fig. 1-18 640X  
Area B. A closer view of the center  
of Fig. 1-17.

Figures 1-16 to 1-18 Area B: These macrographs show the final shear lip. Here we see features similar to those in area A.

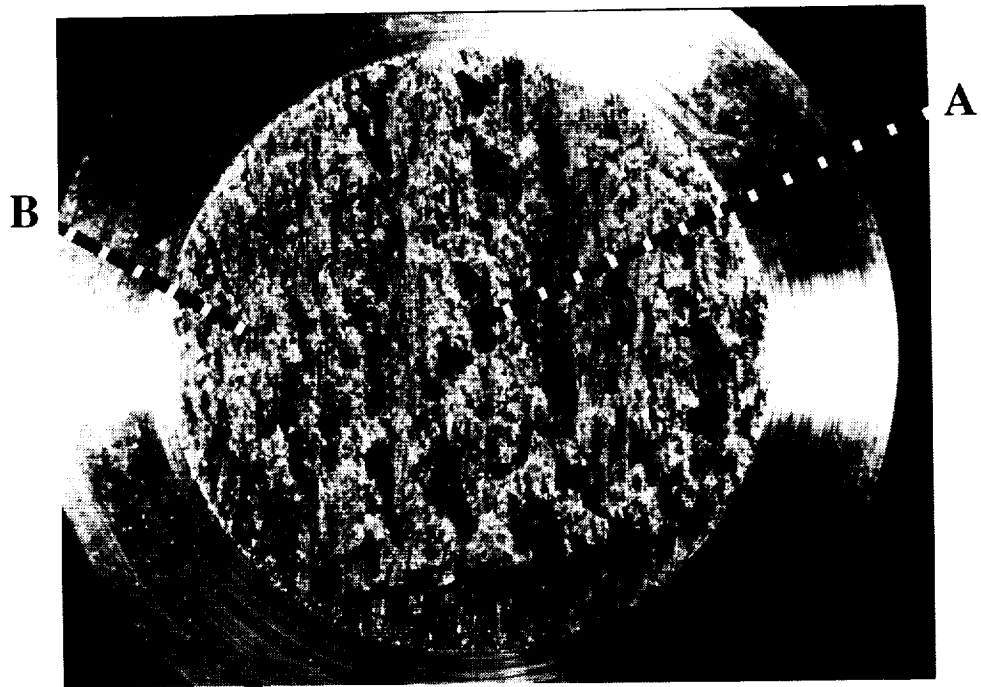
Fig. 1-19  
Optical photomicrograph of the fracture surface.

The surface looks rough yet planar due to the circumferential notch as seen in Figure 1-19. The planar surface is attributed to the notch acting as a stress concentrator and thus reducing plasticity. Rolling of the metal accounts for the oriented features. Two areas were chosen for close examination: Area A near the core of the sample; and area B which is close to the notched edge.

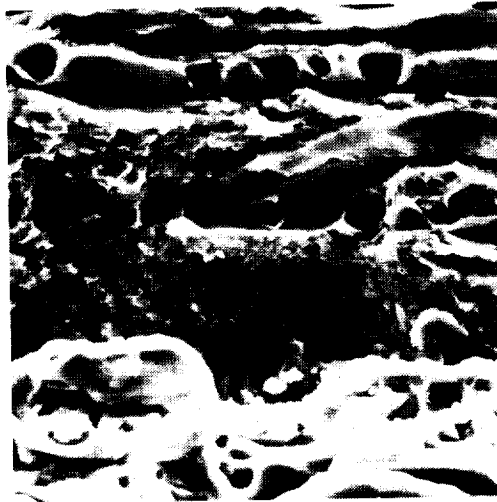
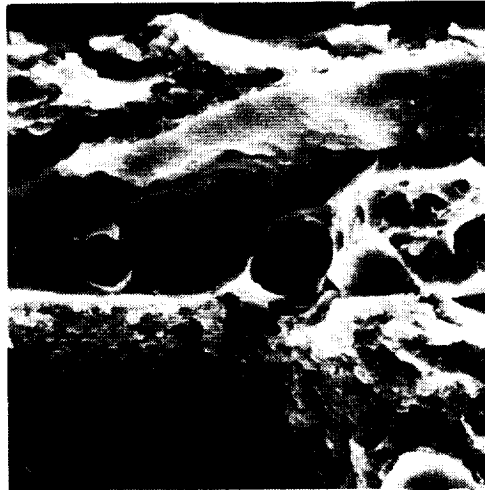
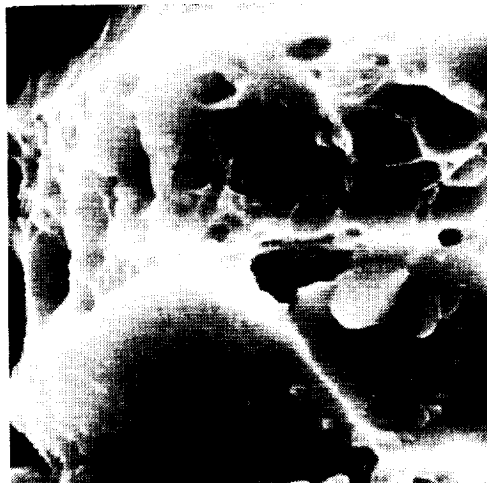
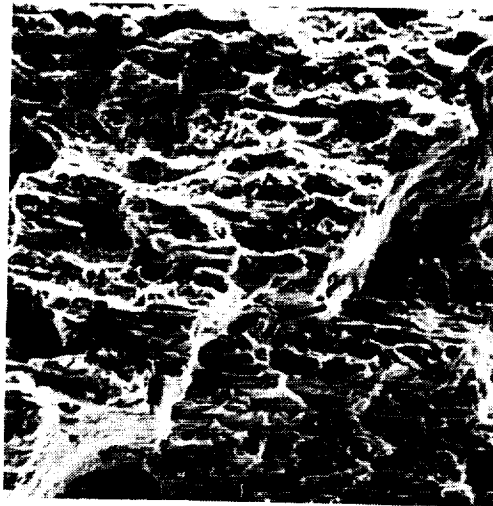
Fig. 1-20 640X  
Area A. A view of the center of the fracture surface.

Fig. 1-21 1250X  
Area A. A closer view of the center of Fig. 1-20.

Fig. 1-22 5000X  
Area A. Microdimples found in the center of Fig. 1-21.

Fig. 1-23 160X  
Area A. Steps located in the core of  
the sample.

Figures 1-20 to 1-23 Area A: Ductility is evident in the form of dimples throughout the core of the sample. Inclusions and large dimples are seen in Figures 1-20, 1-21, 1-22. Note the steps in Figure 1-23.

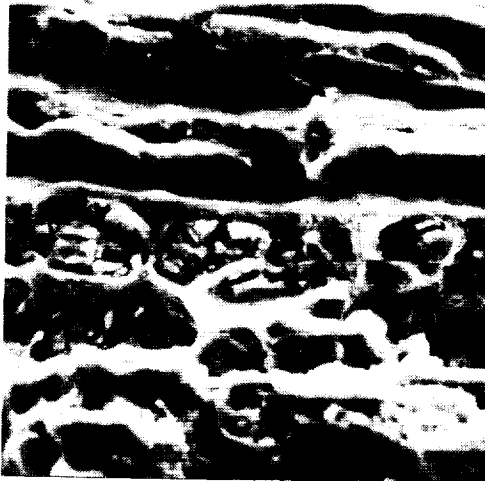
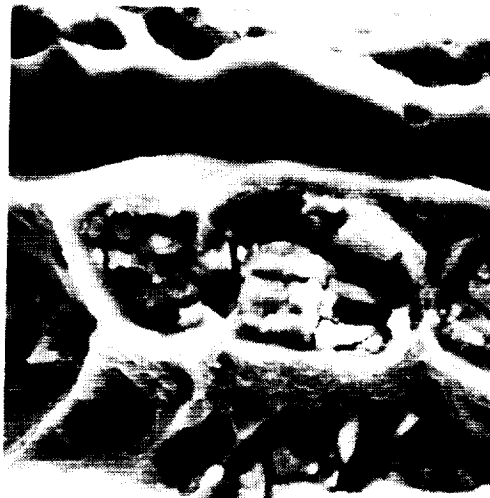
Fig. 1-24 640X  
Area B. Similar features to those at  
the core are found near the notch.

Fig. 1-25 1250X  
Area B. A closer view of the center  
of Fig. 1-24.

Figures 1-24 and 1-25 Area B: The area near the notch has the same features as the core.

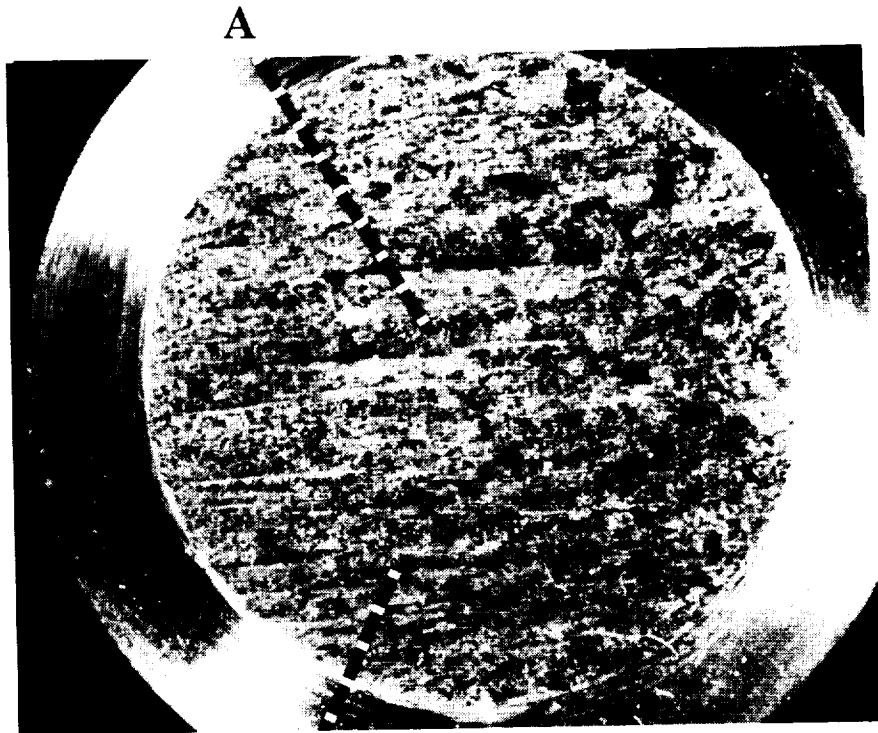
Fig. 1-26  
Optical photomicrograph of the fracture surface.

Figure 1-26 shows that the fracture surface looks much like that of its room temperature counterpart. The rolled, oriented structure is slightly more pronounced and the surface is flatter.

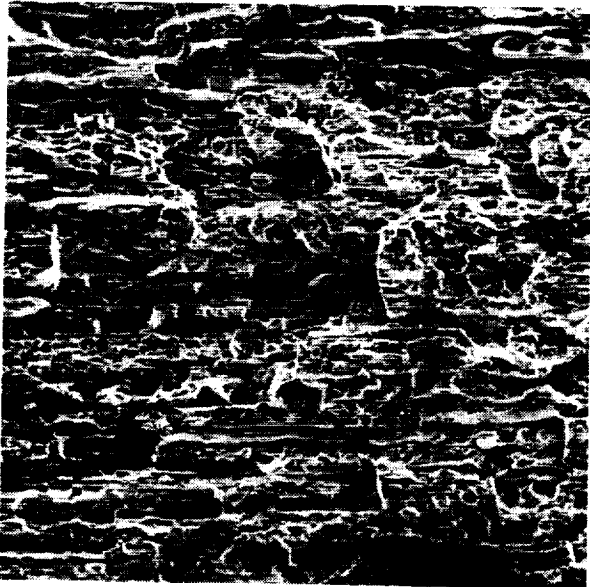
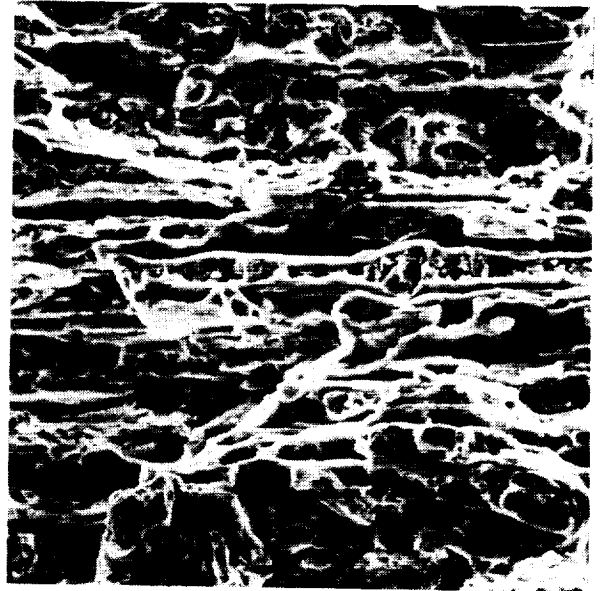
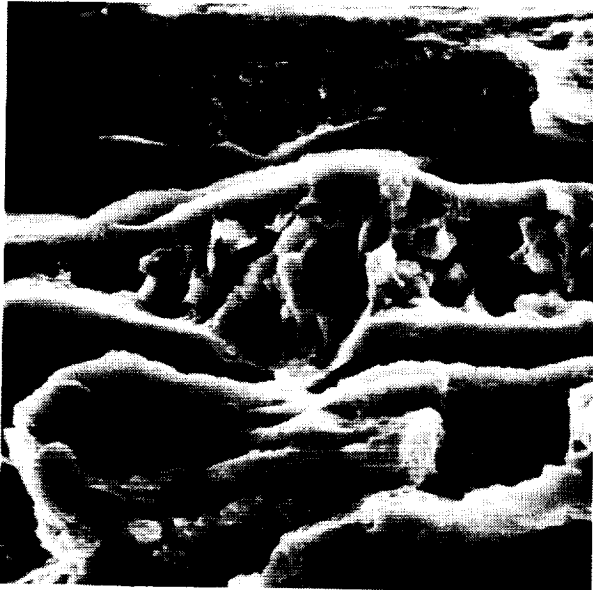
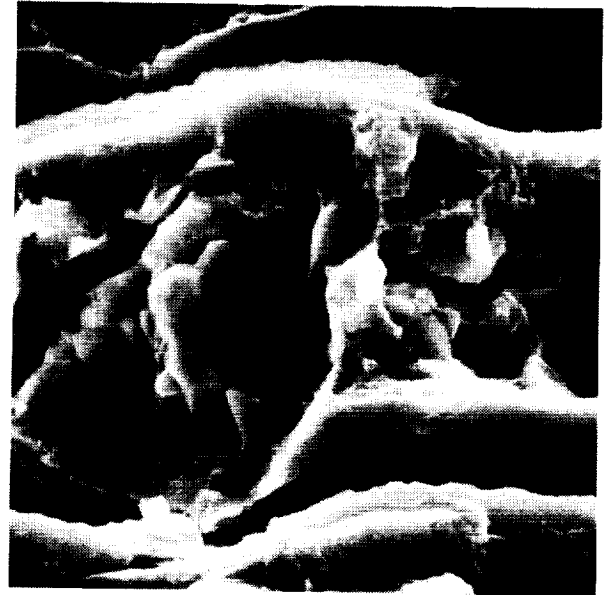
Fig. 1-27 80X  
Area A. Rolled orientation and steplike features.

Fig. 1-28 320X  
Area A. The center of Fig. 1-27.

Fig. 1-29 1250X  
Area A. An area in th center of Fig. 1-28.

Fig. 1-30 2500X  
Area A. Fine dimples from Fig. 1-29.

Figures 1-27 to 1-30 Area A: This area near the center of the specimen shows the same rolled appearance as the room temperature sample. There are fractured second phase inclusions in many of the elongated dimples. Note that very fine dimples are located on the ridges surrounding the inclusions in Figure 1-30.

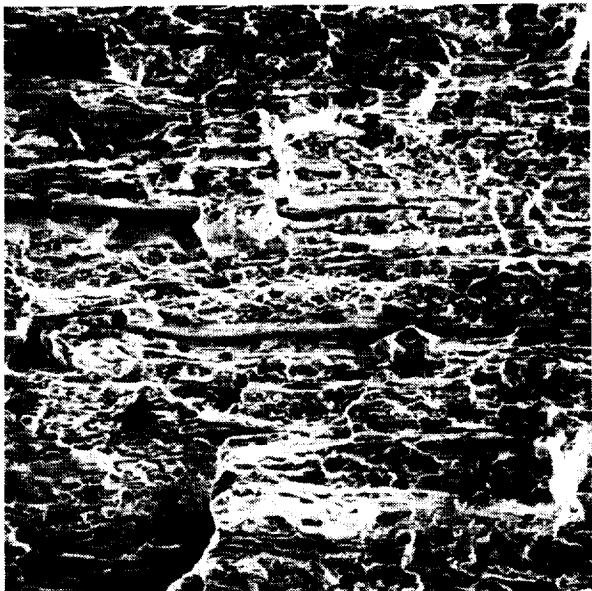
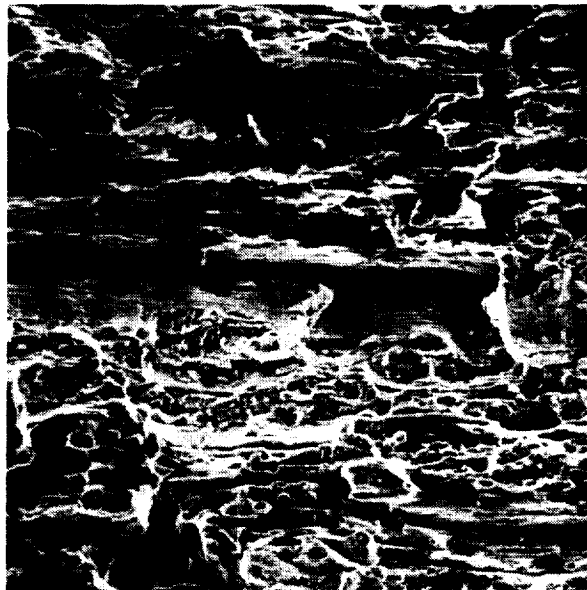
Fig. 1-31  
Area B. 80X

Fig. 1-32  
Area B. A closer view of Fig. 1-31. 160x

Figures 1-31 to 1-34 Area B: These micrographs document an area closer to the notch. The rolled structure is accompanied by steps and transgranular cracks.

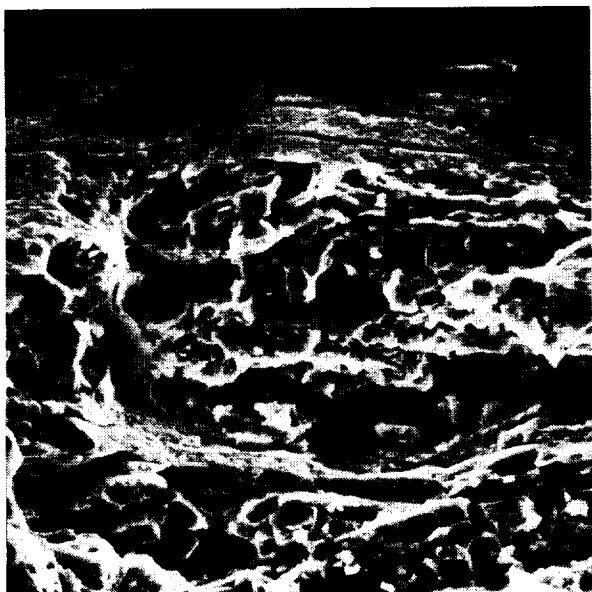
Fig. 1-33  
Area B. 640X

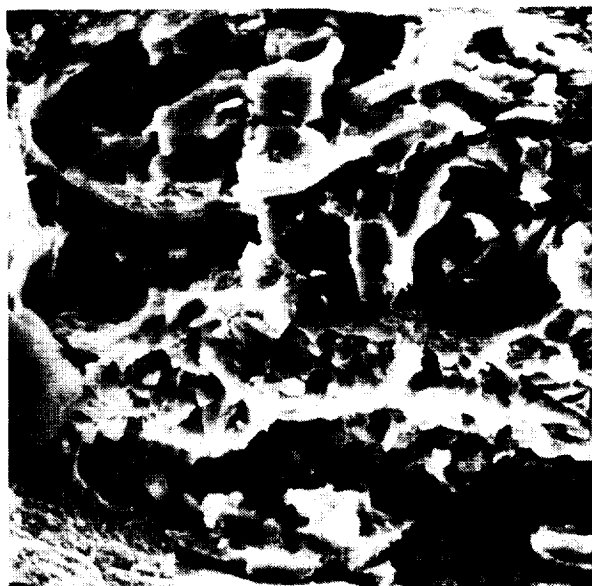
Fig. 1-34  
Area B. 1250X

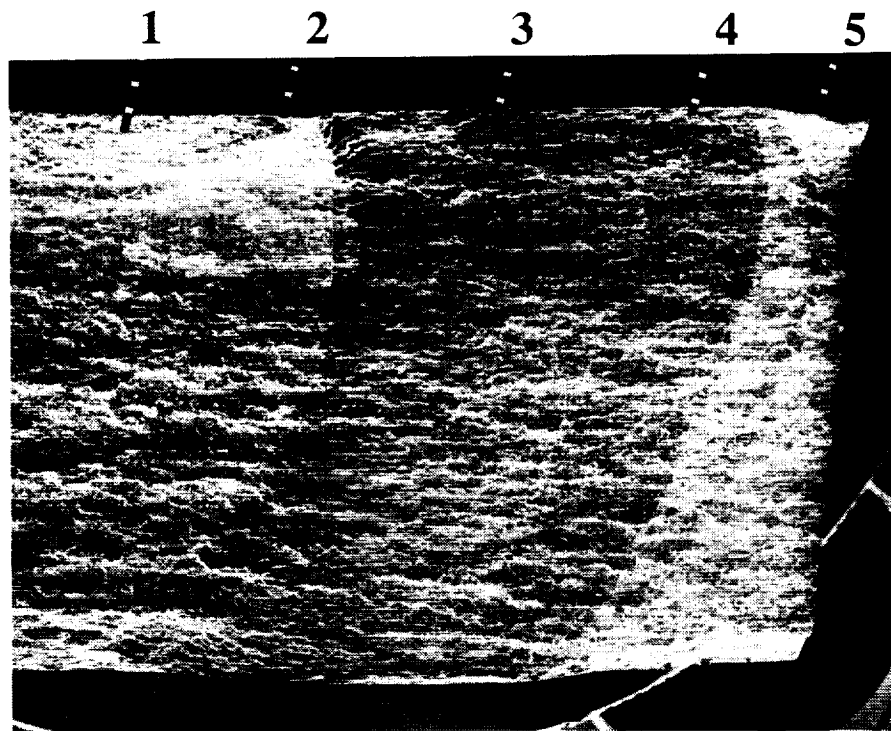
10X

Fig. 1-35  
SEM photomicrograph

Five distinct regions of fracture are visible in the SEM fractograph in Figure 1-35. Region 1 is the precrack region and region 5 is the fast fracture region. The other three regions were documented with SEM fractographs. These regions were loaded under the conditions listed in the chart below, where R represents the ratio of minimum to maximum load and  $K_{max}$  is the maximum crack tip stress intensity.

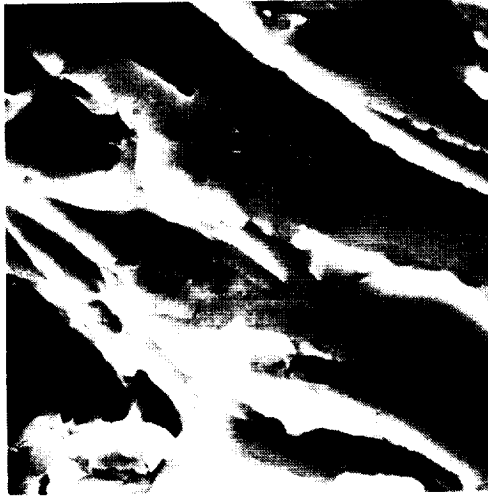
Fig. 1-36 1250X  
Region 2. Faint fatigue striations.

Figures 1-36 to 1-38 Region 2: The striations are very faint and closely spaced.

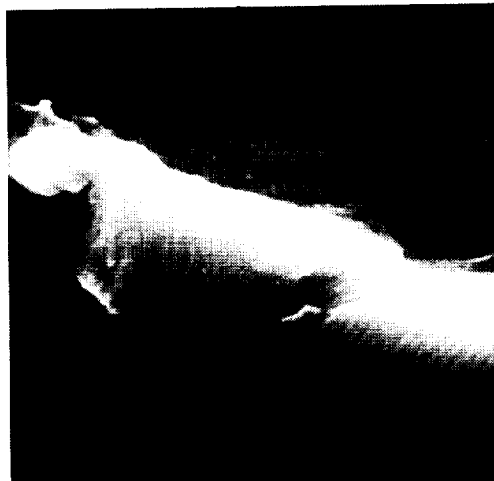
Fig 1-38 5000X  
Region 2.

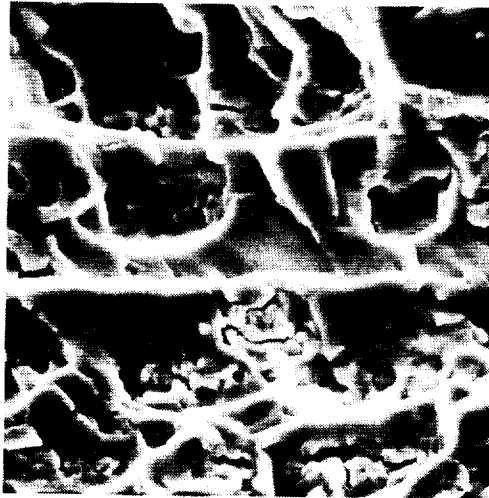
Fig 1-39 640X  
Region 3. Fatigue striations.

Figures 1-39 to 1-41 Region 3: Several magnifications of the same area showing fairly largely spaced striations.

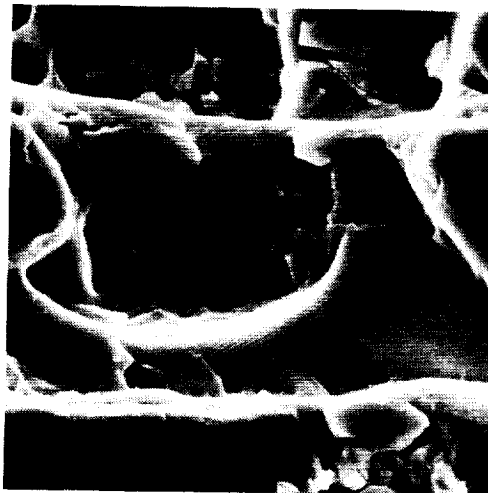
Fig. 1-40 1250X  
Region 3.

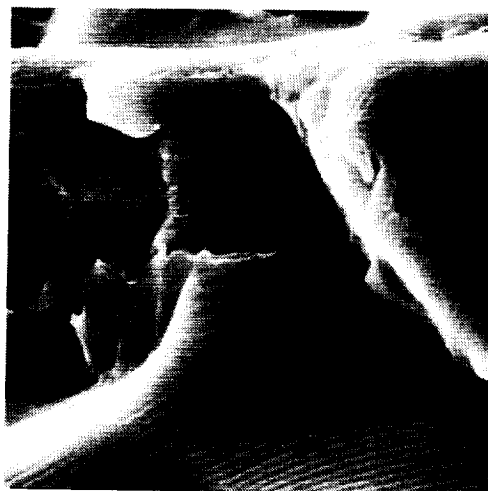
Fig. 1-41 2500X  
Region 3

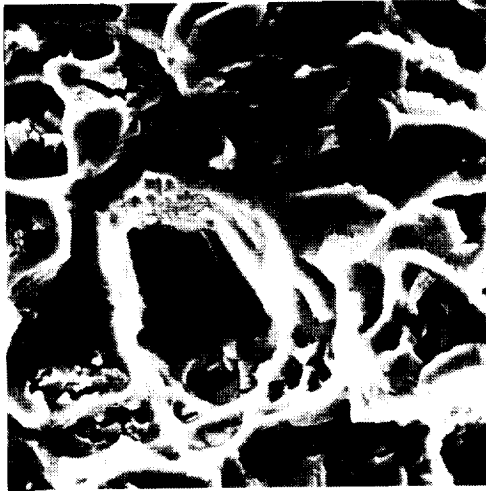
Fig. 1-42 640X  
Region 4. Fatigue striations.

Figures 1-42 to 1-44 Region 4: Again the striation spacing appears fairly large which is expected for the small R value.

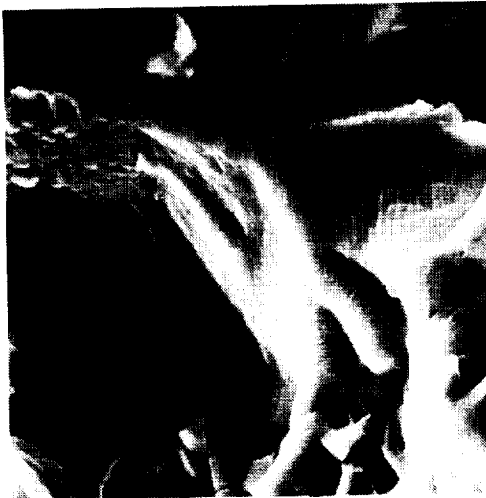
Fig. 1-43 1250X  
Region 4.

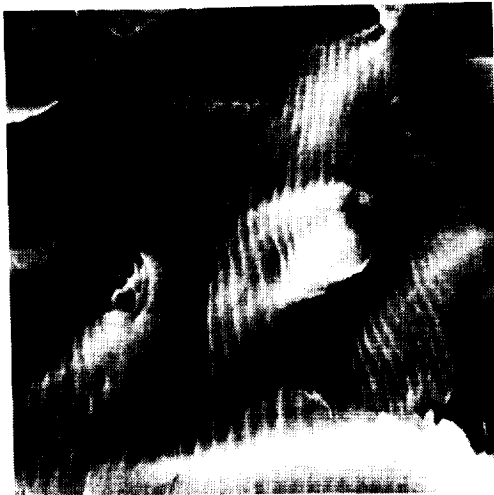
Fig. 1-44 2500X  
Region 4.

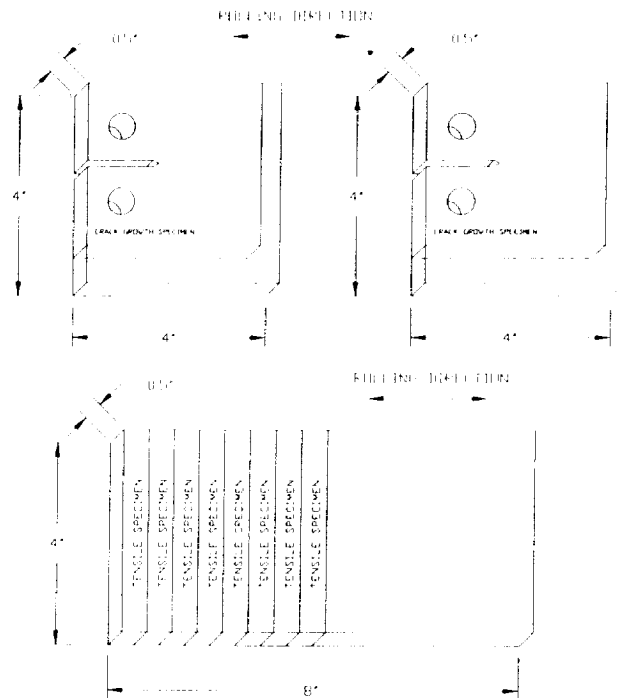
Figure 2-a, Pattern for cutting test specimens.

Initial condition was plate, mill finish, interleaved, per fed spec. QQ-A-230/11E. Heat treatment: T651- solution heat-treated and stress relieved by stretching. Hardness: HRB 58. Dimensions: 0.5" Tk X 46.5" W X 144.5" L. Specimens were cut from the plate according to the diagram in Figure 2-a.

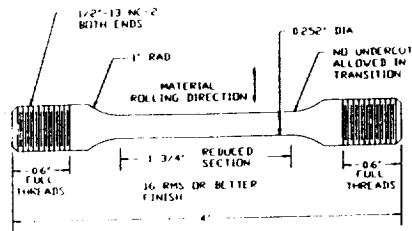
Figure 2-b. Smooth tensile overload specimen,  
4" long, 0.252" diameter

Smooth tensile overload specimens have the dimensions as shown in Figure 2-b and notched overload specimens have the dimensions as shown in Figure 2-c. Compact tension specimens have the dimensions as shown in Figure 2-d.

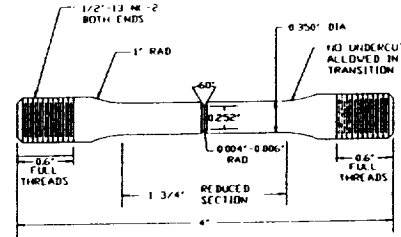
Figure 2-c. Notched tensile overload specimen,  
4" long, 0.004-0.006" root radius,  
0.252" notch diameter.

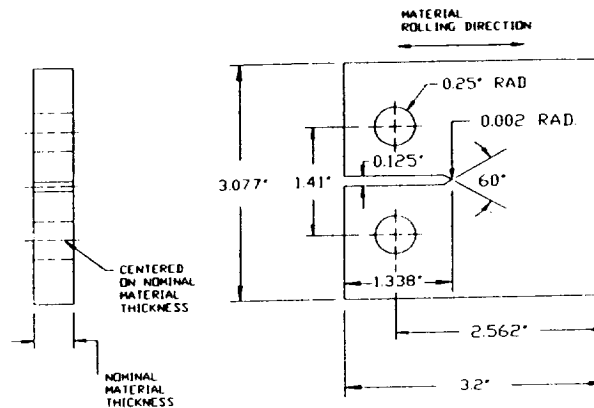
Figure 2-d, Compact tension specimen.

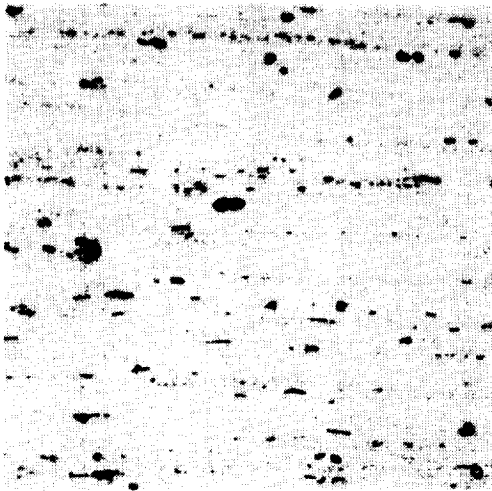
Fig. 2-1

200X

Keller's etchant (1 ml HF, 1.5 ml HCl, 2.5 ml HNO<sub>3</sub>, 95 ml H<sub>2</sub>O) used for all micrographs. Figures 2-1 and 2-2 show gray, scriptlike particles of Fe<sub>3</sub>SiAl<sub>12</sub>.

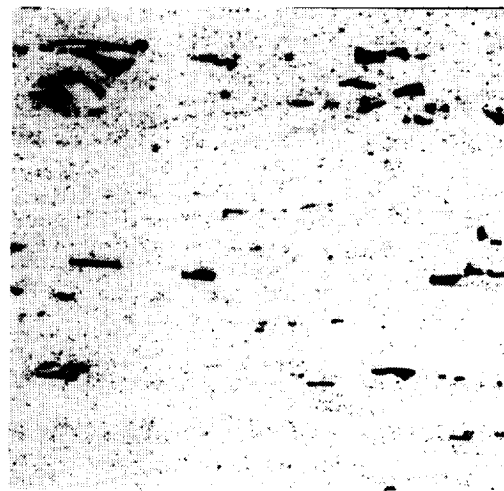
Fig. 2-2

400X

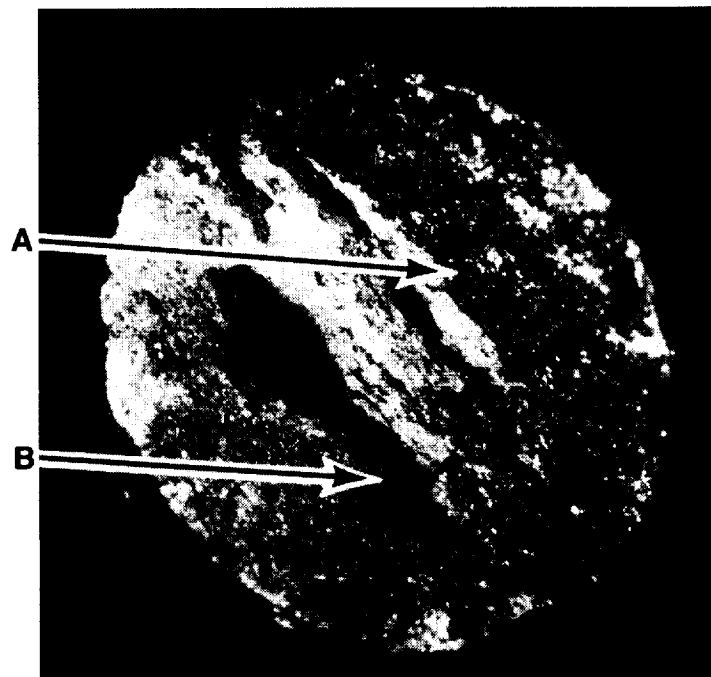
Fig. 2-3

Optical photomicrograph of fracture surface.

The fracture surface shown in Figure 2-3 has a central region which is composed of two ridges running parallel to two distinct shear lips displaying different inclinations to the specimen axis. Area A is of the shear lip and Area B is near the center of the sample.

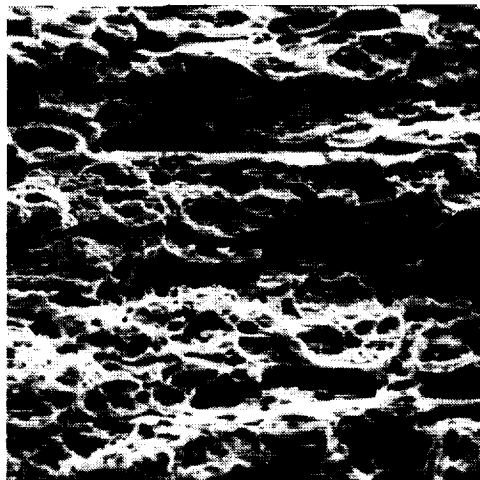
Fig 2-4 320X  
Region A. Shear lip area.

Figures 2-4 to 2-6 Area A: These micrographs show typical features of area A on the upper and lower shear lip. Note the ductile dimples and the brittle inclusions configured in layers which reflect the oriented structure.

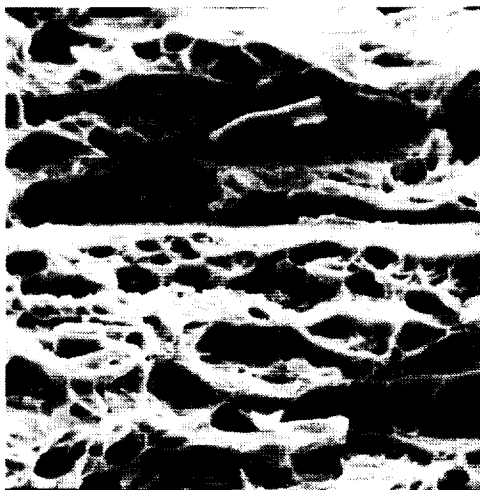
Fig 2-5 640X  
Region A.

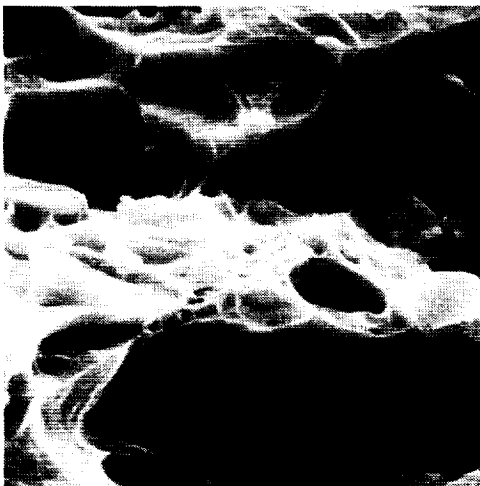
Fig 2-6 2500X  
Region A. Ductile dimples.

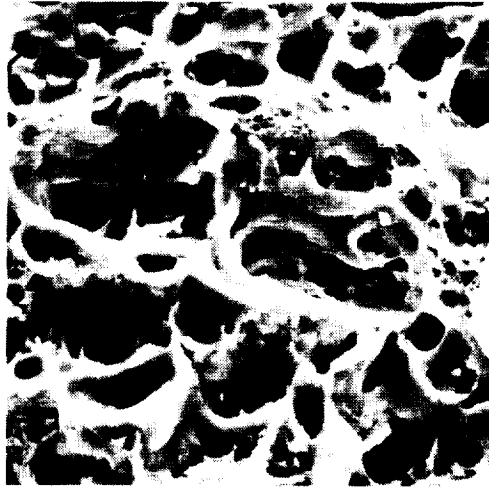
Fig 2-7 640X  
Region B. Core of sample.

Figures 2-7 to 2-9 Area B: These macrographs show features typical of the center of the sample. The features are similar to those found on the shear lip.

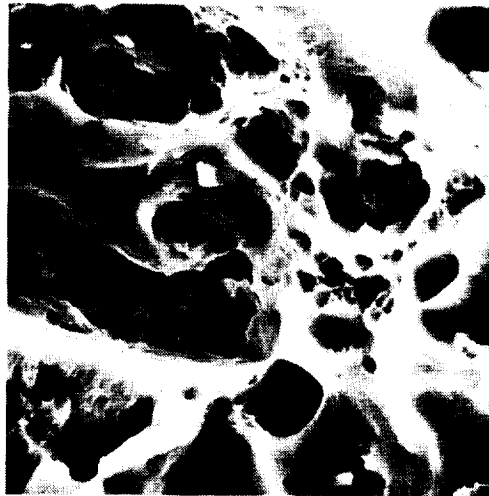
Fig 2-8 1250X  
Region B. Large and small dimples.

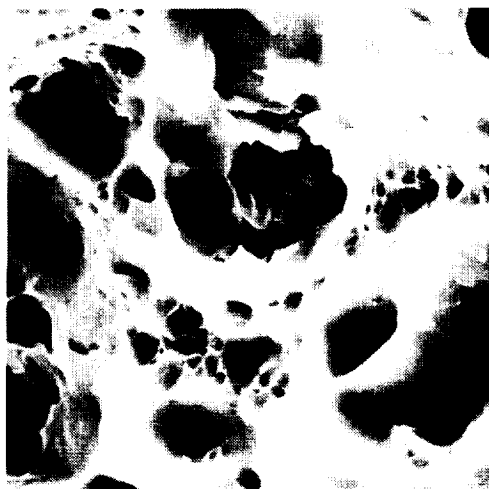
Fig 2-9 2500X  
Region B. Microdimples.

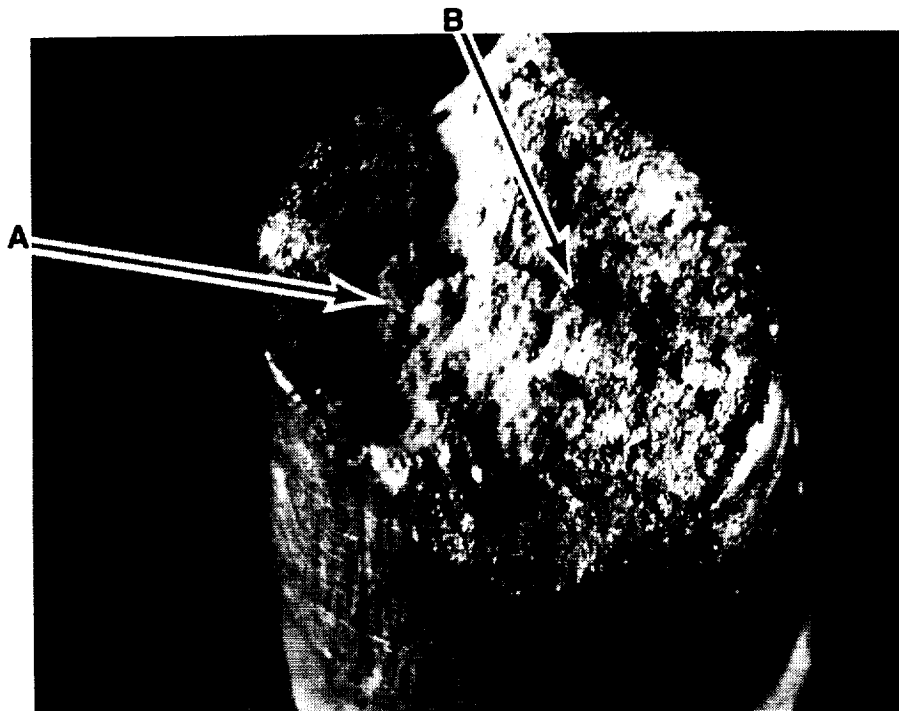
Fig. 2-10  
Optical photomicrograph of fracture surface.

The macrograph of this smooth 77 K temperature tensile overload sample is displayed in Figure 2-10. This specimen exhibits a rough central region with a shear lip and jagged point on the edges. Area A represents the shear lip and B the central zone of fracture.

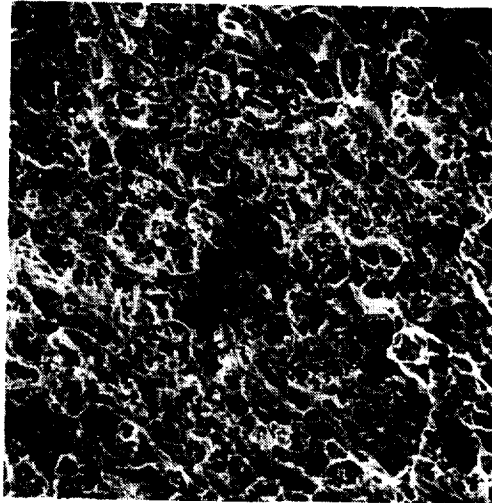
Fig. 2-11 160X  
Region A. Shear lip region.

Figure 2-11 to 2-13 Area A: This area represents the shear lip region. Note that the dimples are smaller than in the smooth room temperature sample. Also the layered orientation is less evident. The colder temperature has impeded necking and plastic deformation.

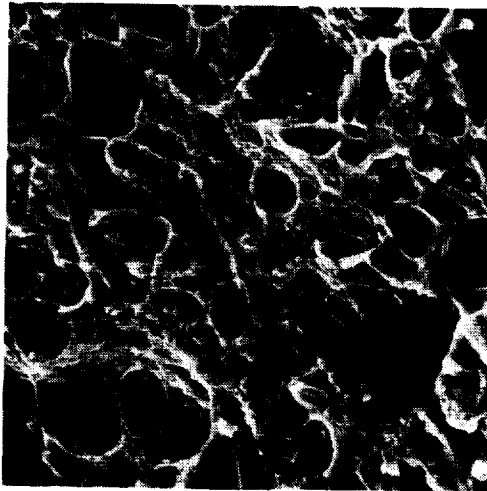
Fig 2-12 640X  
Region A. Shear lip region. Note the size variation of the ductile dimples.

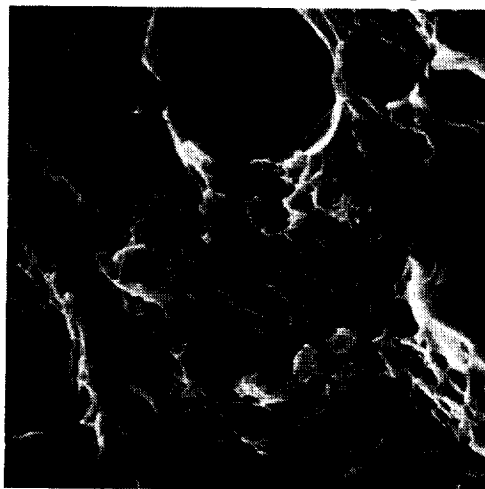
Fig 2-13 2500X  
Region A. Microdimples in the shear lip region.

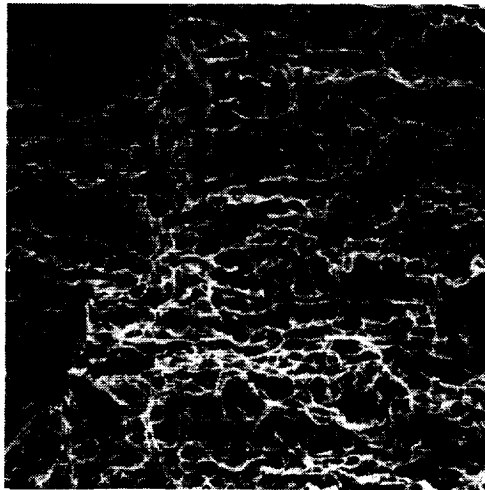
Fig 2-14 160X  
Region B. Central fracture zone.

Figures 2-14 and 2-16 Area B: The dimples appear larger in the central zone of the fracture than on the shear lip. There are more features such as steps and small ridges here.
